DEPARTMENT OF TRANSPORTATION

Contract #: 04-0120F4Cty: SF/ALA Rte: 80 PM: 13.2/13.9File #: 69.28**WELDING INSPECTION REPORT****Resident Engineer:**Siegenthaler, Peter**Address:** 333 Burma Road**City:** Oakland, CA 94607**Report No:** WIR-017550**Date Inspected:** 11-Oct-2010**Project Name:** SAS Superstructure**OSM Arrival Time:** 700**Prime Contractor:** American Bridge/Fluor Enterprises, a JV**OSM Departure Time:** 1900**Contractor:** Zhenhua Port Machinery Company, Ltd (ZPMC), Changxing Island **Location:** Shanghai, China**CWI Name:** Mr.Qiu Wen.**CWI Present:** Yes No**Inspected CWI report:** Yes No N/A**Rod Oven in Use:** Yes No N/A**Electrode to specification:** Yes No N/A**Weld Procedures Followed:** Yes No N/A**Qualified Welders:** Yes No N/A**Verified Joint Fit-up:** Yes No N/A**Approved Drawings:** Yes No N/A**Approved WPS:** Yes No N/A**Delayed / Cancelled:** Yes No N/A**Bridge No:** 34-0006**Component:** Tower and Orthotropic Box Girder (OBG)**Summary of Items Observed:**

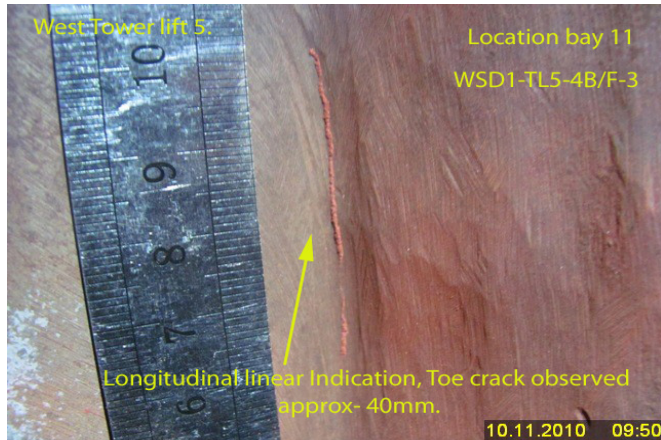
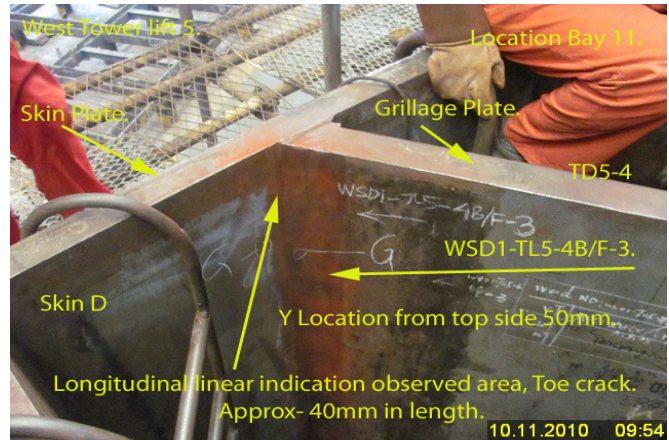
During the Quality Assurance (QA) Magnetic Particle Testing (MT) review of welds located in West Tower lift 5 Grillage plate, WSD1-TL5-4B/F-3, this Quality Assurance (QA) Inspector discovered the following issues One (1) Longitudinal linear indication, Toe crack measuring approximately 40mm in length. The weld is identified as: WSD1-TL5-4B/F-3. The Weld is a (CJP) completed joint penetration weld, joining the grillage plate to skin plate. The material is designated as Non Seismic Performance Critical Member (NON SPCM). The member is located in Bay 11. The Notice of Witness Inspection Number (NWIT) is 06917. The indication is located on CJP weld area that has been previously tested and accepted by ZPMC Quality Control (QC) personnel. As per the contract documents, ZPMC's QC personnel are required to perform one hundred (100) percent MT inspection of this weld.

The attached photographs provide additional detail This QA inspector generated incident report for this date.
